Manhole Inspection Summary

Manhole # S39MM_042MH

Insp Date: **3/1/07 10:43 AM**

Location Address: **1903 AISQUITH ST**

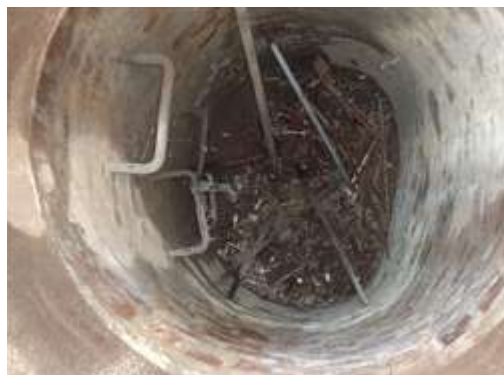
Top View

Barrel infiltration. Channel debris.

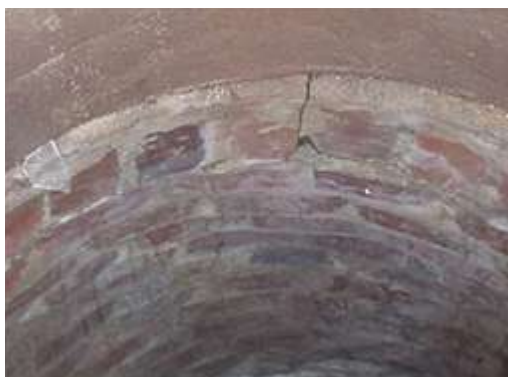
Defect

Frame leaks. Adjustment deterioration, cracks and infiltration.

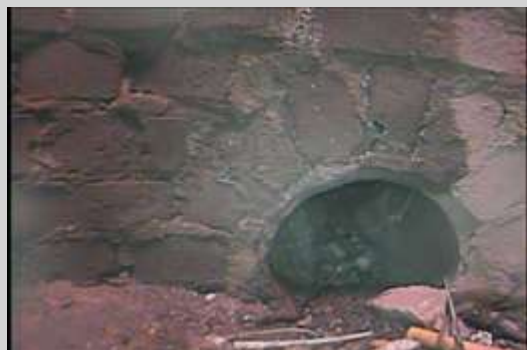
Pipe Out @ 12 O'Clock

8 in. Circular Gravity Sewer

Deposits: ☐ None ☒ **Mud** ☐ Sludge ☒ **Debris** ☐ Grease

Silt Depth: **1** (in.)

Deposits Extent: **Light**
